INDUSTRY SAFETY REMINDER

FIELD REPLACEMENT OF CHAMBERS EQUIPPED WITH "WELDED" YOKES

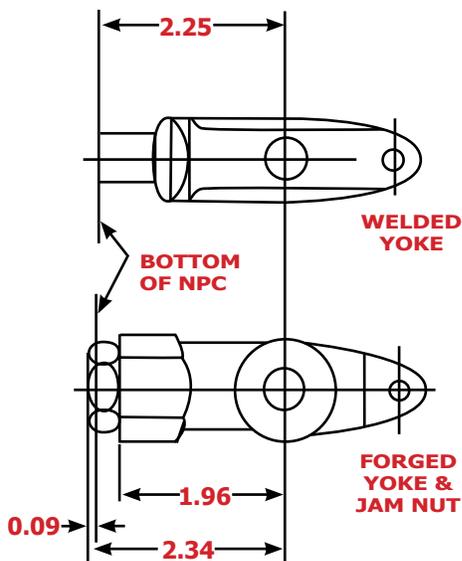
Units manufactured with a "welded" yoke have preset "Y" dimension, measured from the bottom of the NPC to the center-line of the yoke pin, of 2.25 - inches. Because the "Y" dimension is relatively short, the corresponding "X" dimension, measured from the bottom of the NPC to the end of the rod, will also be short, at approximately $\frac{3}{4}$ of an inch.

Consequently, if a replacement unit with a "universal" all-threaded cut-to-fit push-rod is used, the "stack-up" of the yoke and jam nut will exceed the "X" dimension by approximately $\frac{1}{8}$ th of an inch.

In some cases, this will prevent the unit from achieving zero-stroke, or, if the push-rod opening in the NPC is large enough, the jam nut will protrude into the NPC and may damage the protective stone shield.

Therefore, do not use a replacement unit with a universal all-threaded cut-to-fit push-rod to replace a unit with a "welded" yoke.
